TECHNICAL REPORT NO. LWL-CR-06C66A

AIRCRAFT MOUNTED PERSONNEL DETECTOR CHEMICAL

Final Phase IV Report
Contract No. DA-18-001-AMC-983(X)

By
Ordnance Systems
General Electric Company
Pittsfield, Massachusetts 01201

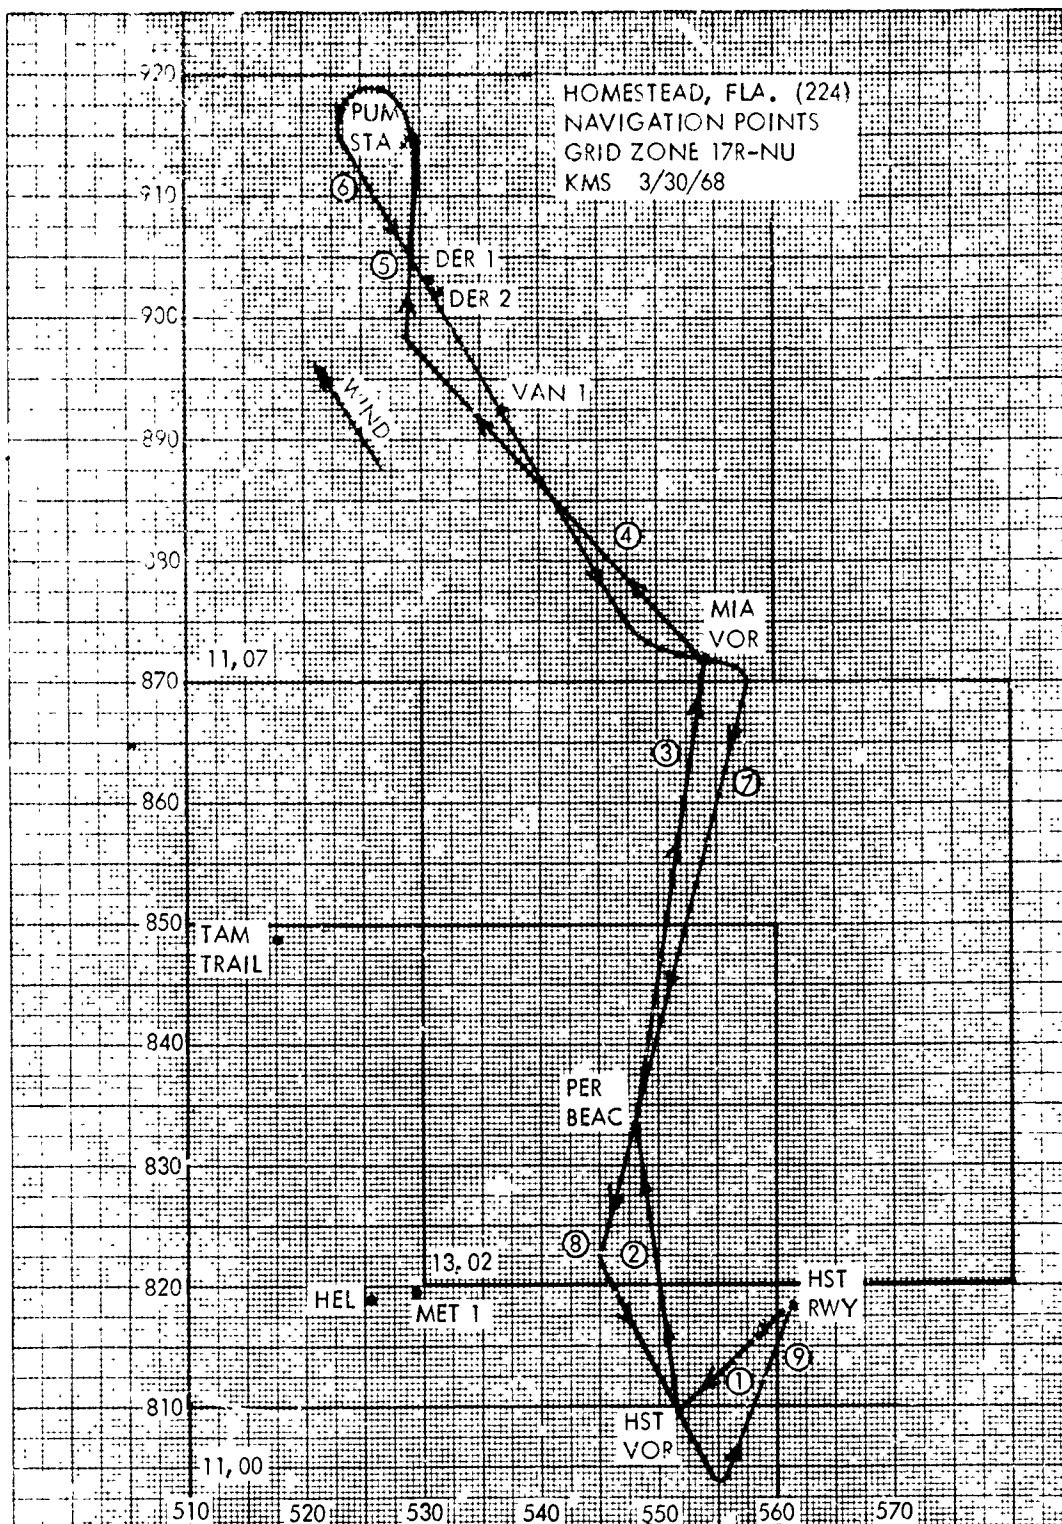
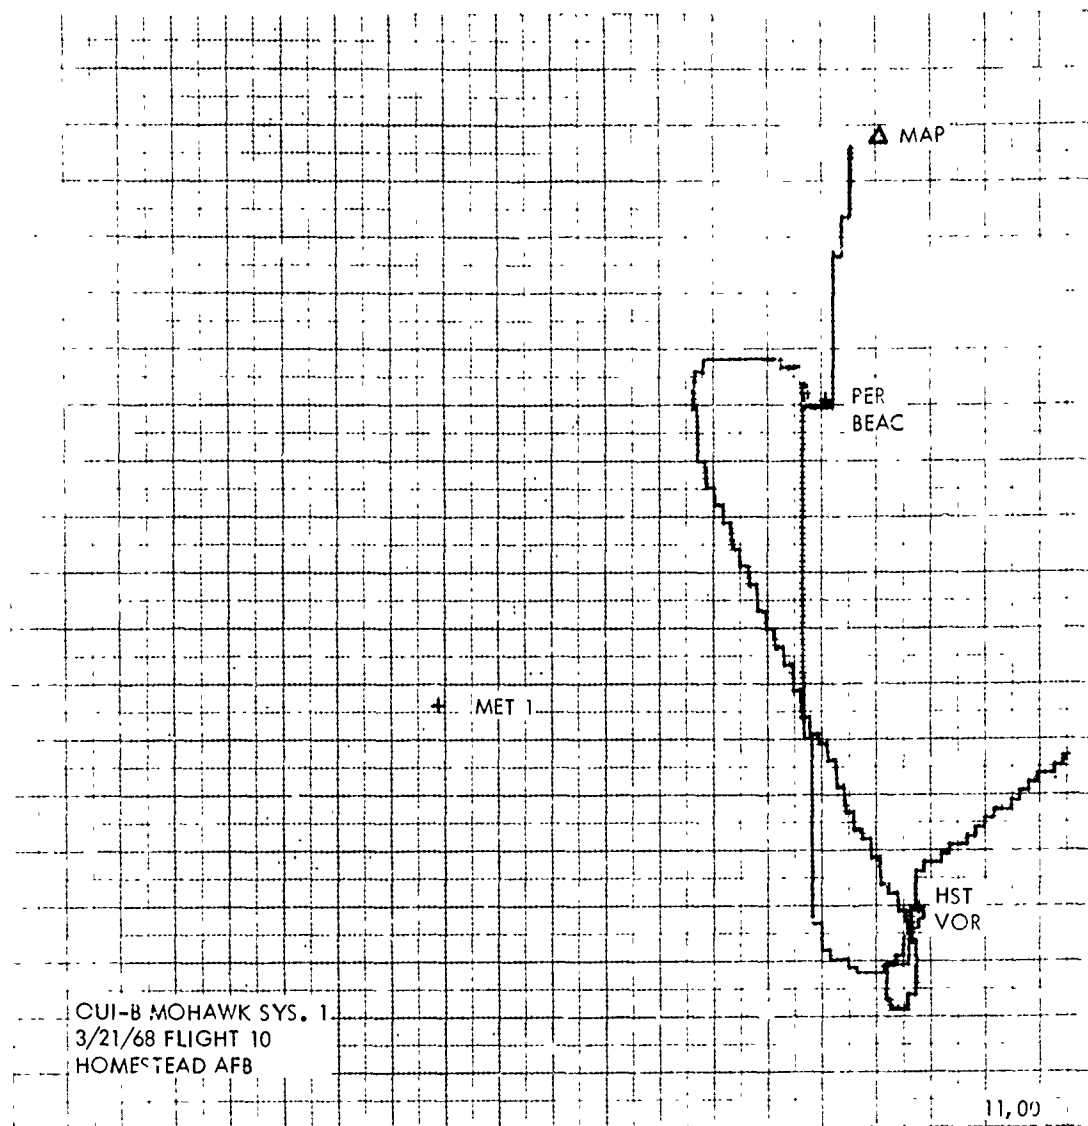
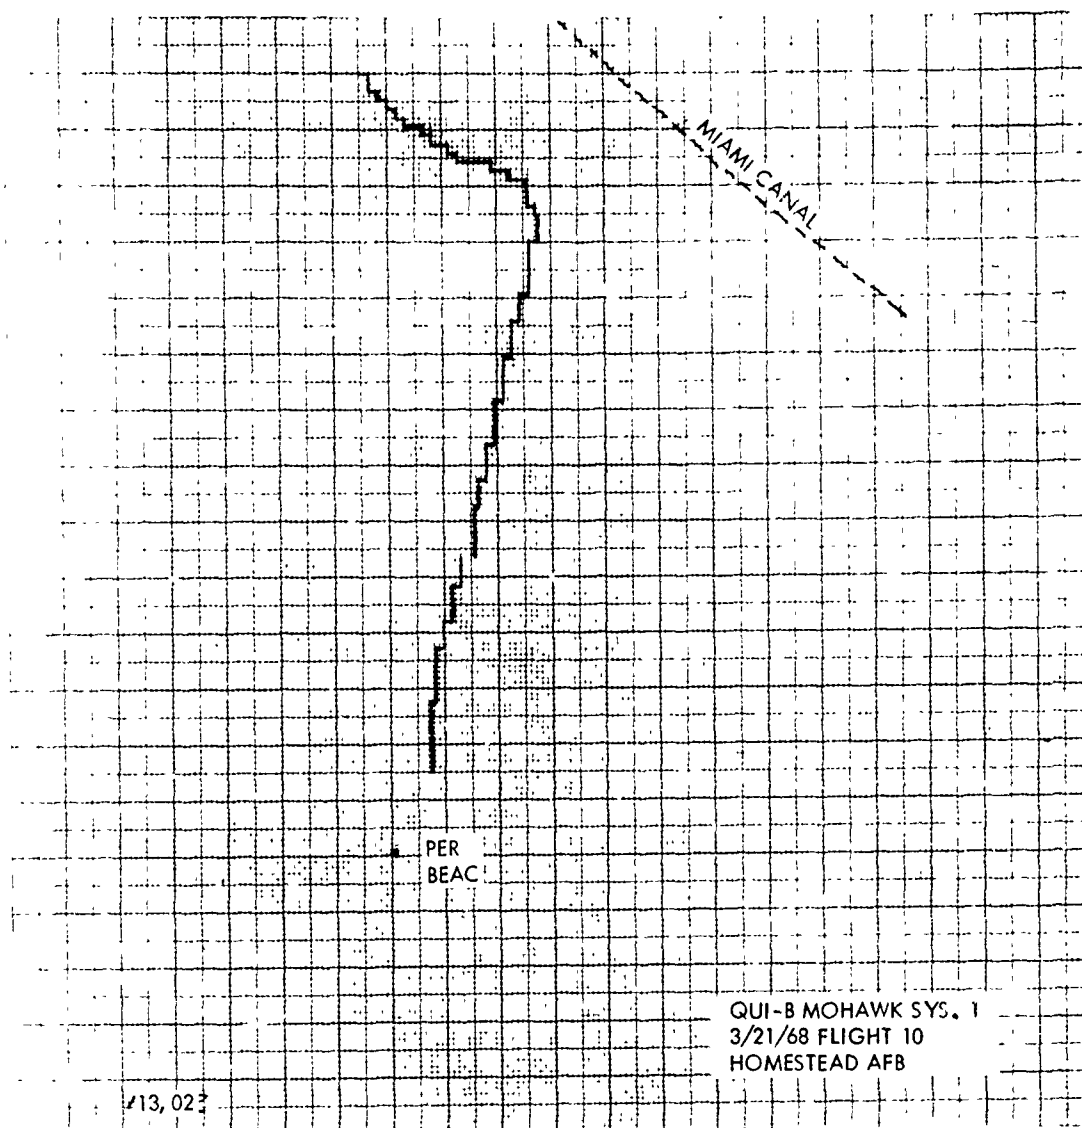
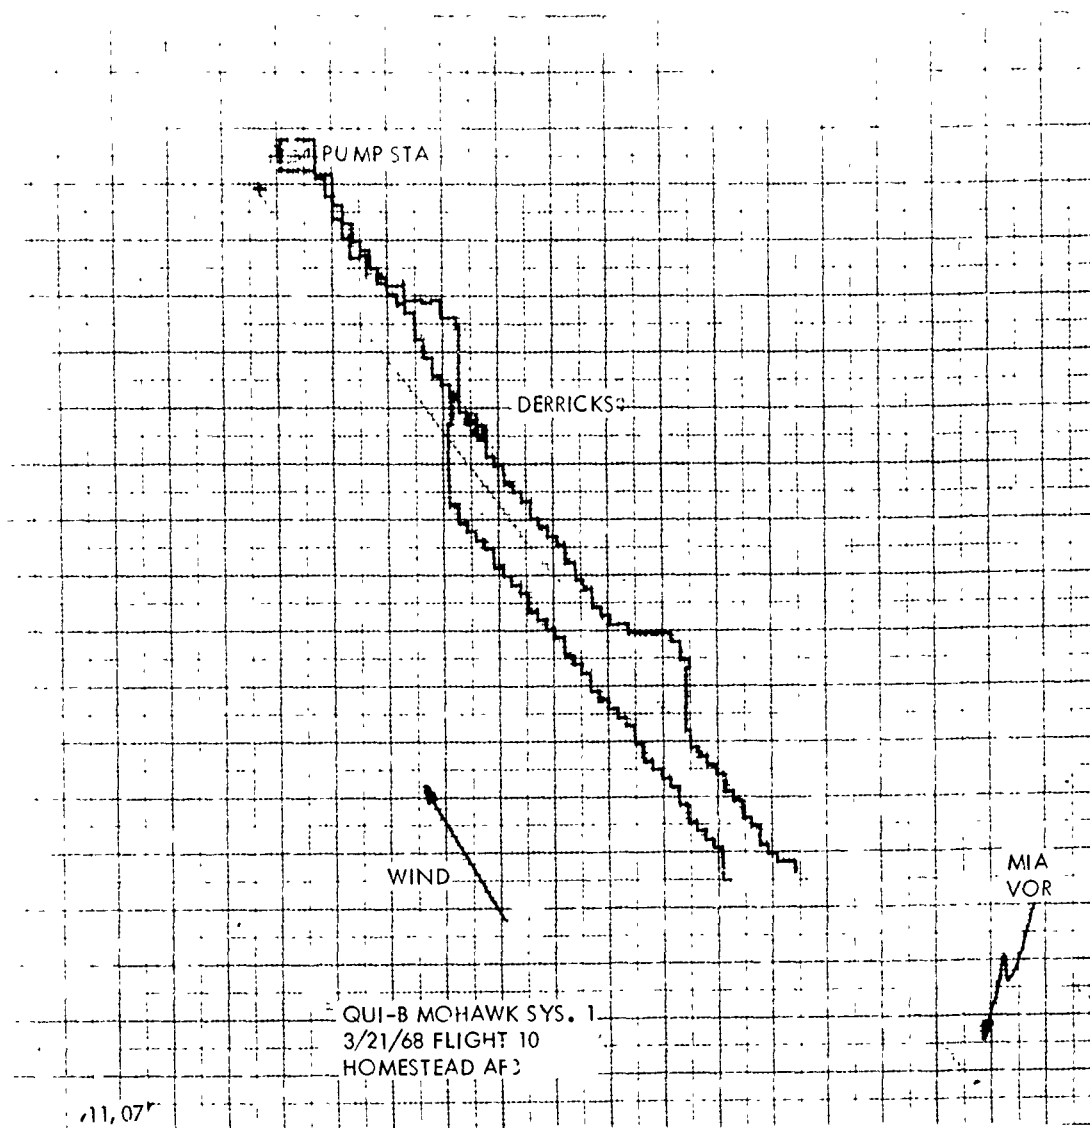
Figure 3-81. Flight 10-JOV1-B (27).

Figure 3-82. Flight 10--J0V1-B (27).

Figure 3-83. Flight 10-JOV1-B (27).

Figure 3-84. Flight 10--JOV1-B (27).

3. 11. 3. 10 Flight 10/21 Mar 68 (Figures 3-81 through 3-84).

Object: Fly North of the AFB to the Miami canal and ensure that map boards can be interchanged without losing plotter/navigator synchronization.

Fly along the down-wind side of the canal at 100 feet, and attempt to make C/N detections of the derricks located in the canal.

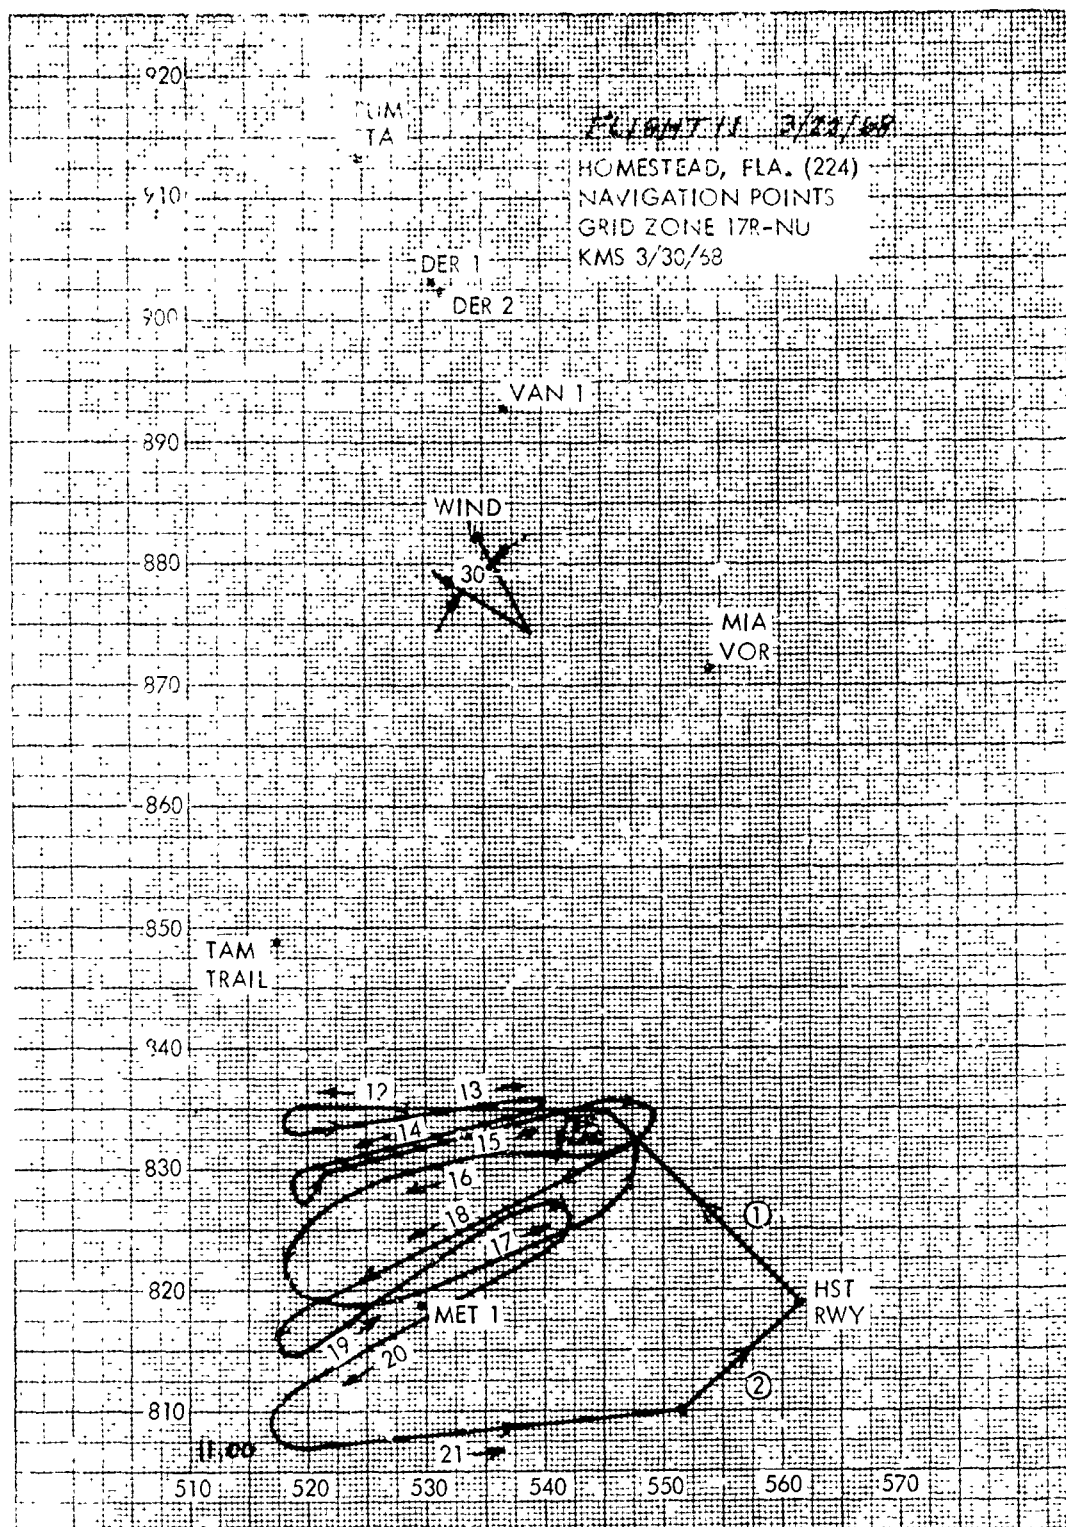
Figure 3-85. Flight 11-JOV1-B (27)

3.11.3.11 Flight 11/22 Mar 68 (Figures 3-85 and 3-86).

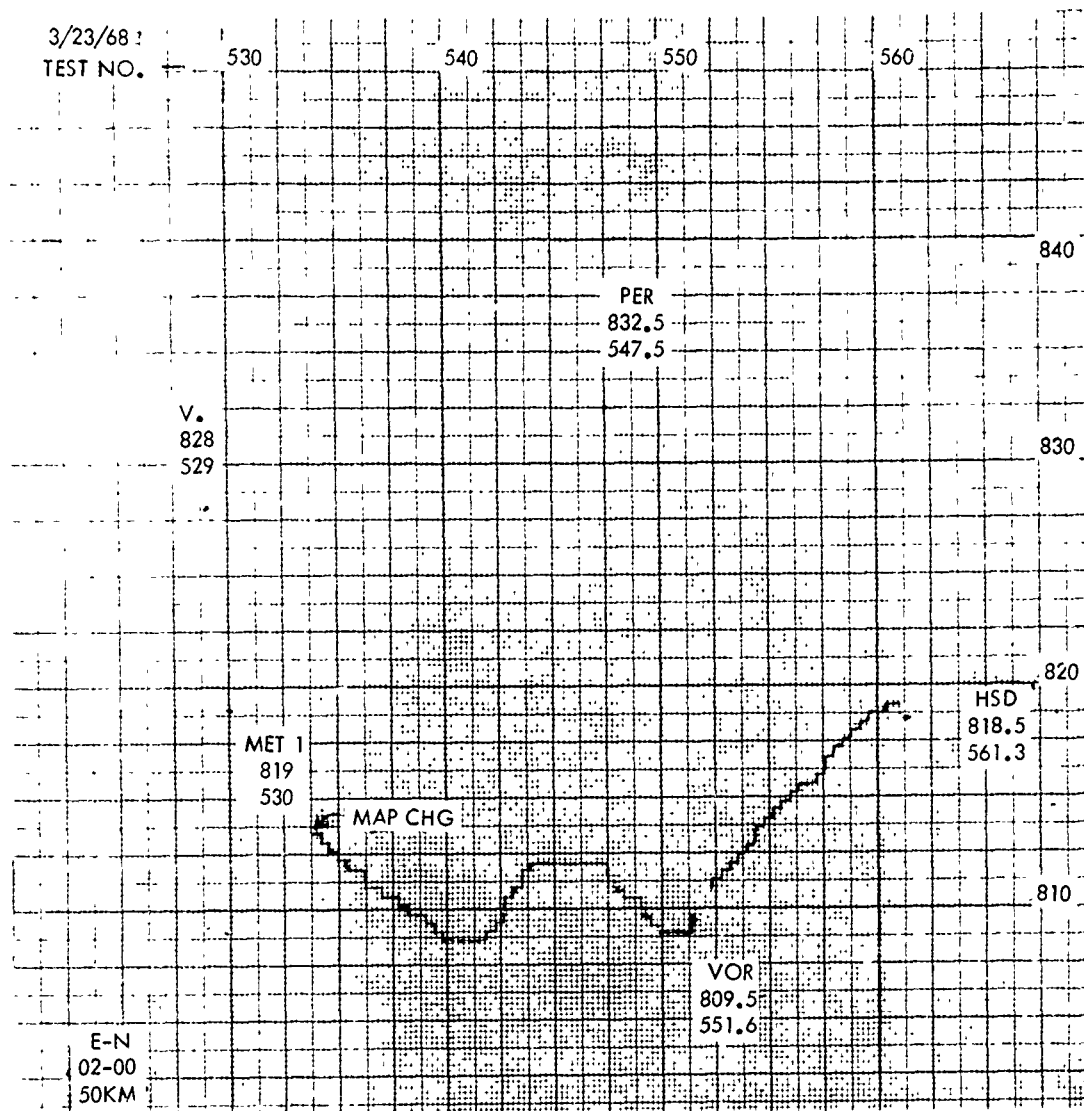
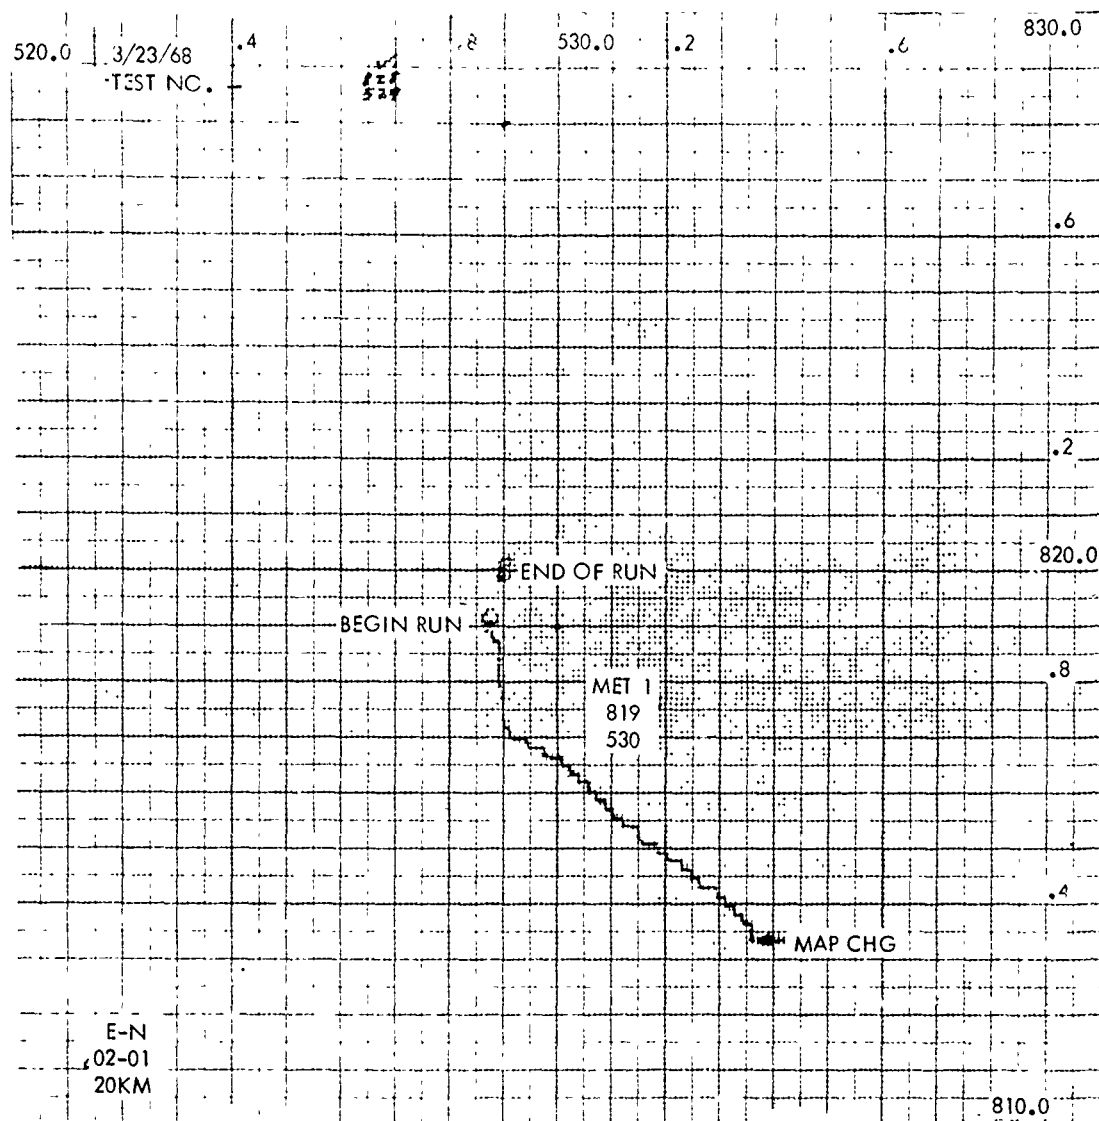
Figure 3-90. Test 530 UH1-D (89).

Figure 3-91. Test 529 UH1-D (89).

The plotter's pen clogged on the way out to Met No. 1, so no useful plot was obtained of the mission. The time-of-day reset for some unknown reason. This was the only malfunction of the time-of-day observed while in Florida. (See figures 3-90 and 3-91 and para 3.12.3.1 data sheet.)

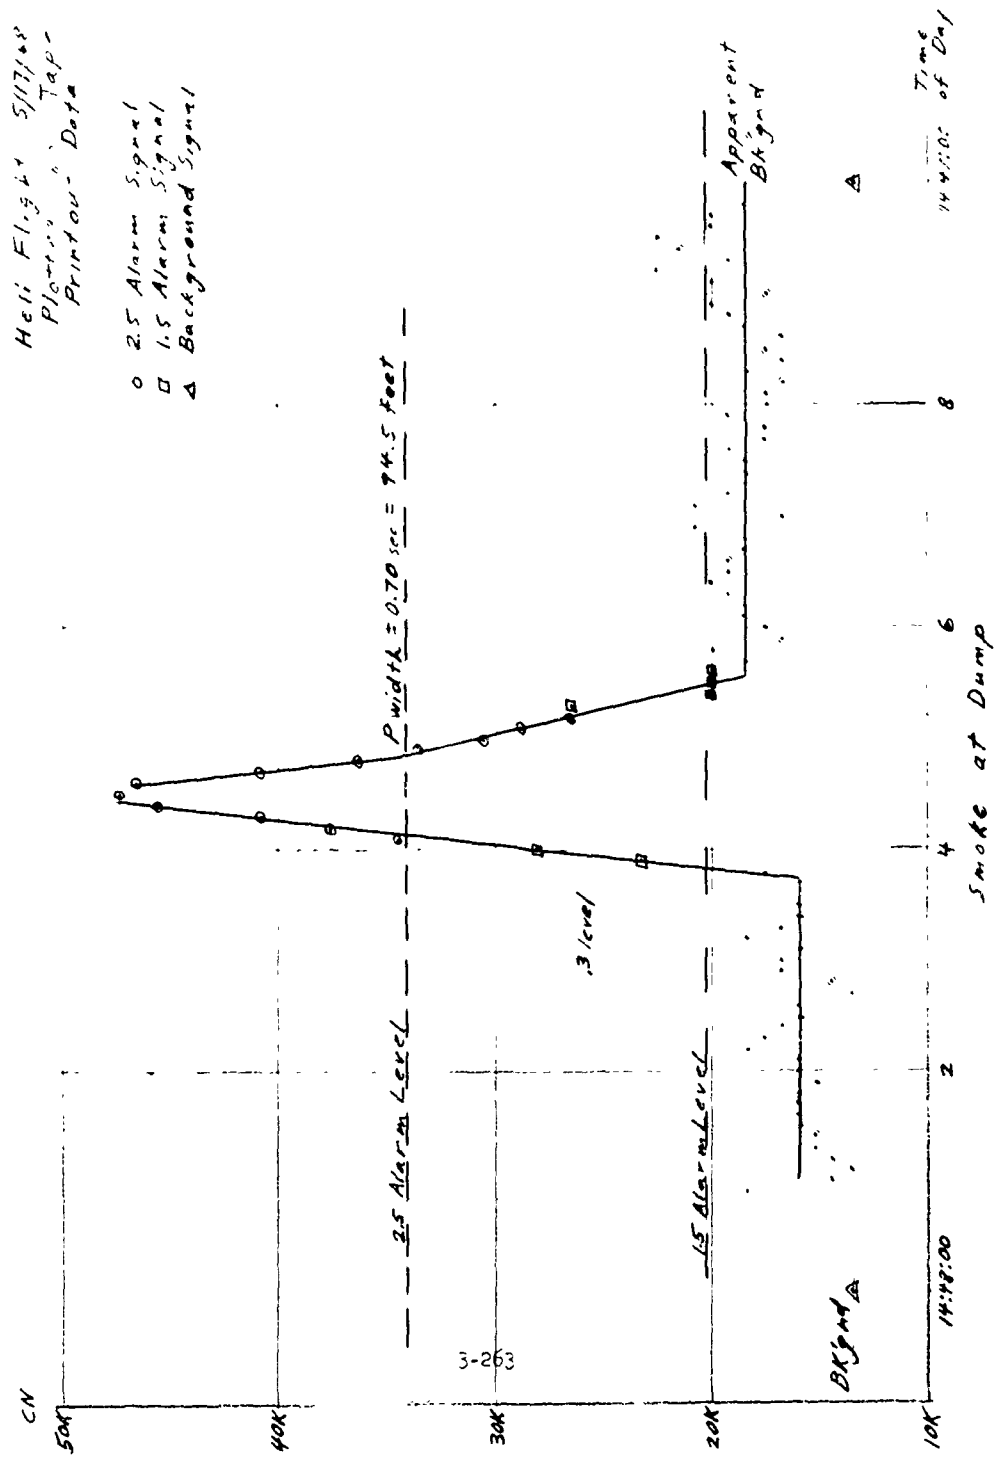
Figure 3-93. Plotted Alarm Signals--UH1-D (89).

4. Chemical subsystem operation was demonstrated by plotting (figure 3-93 from the tape recording print-out) the detection of the smoke plume from the dump. The plot also indicates the alarm received from the analyzer as well as the background level and calculated alarm levels.

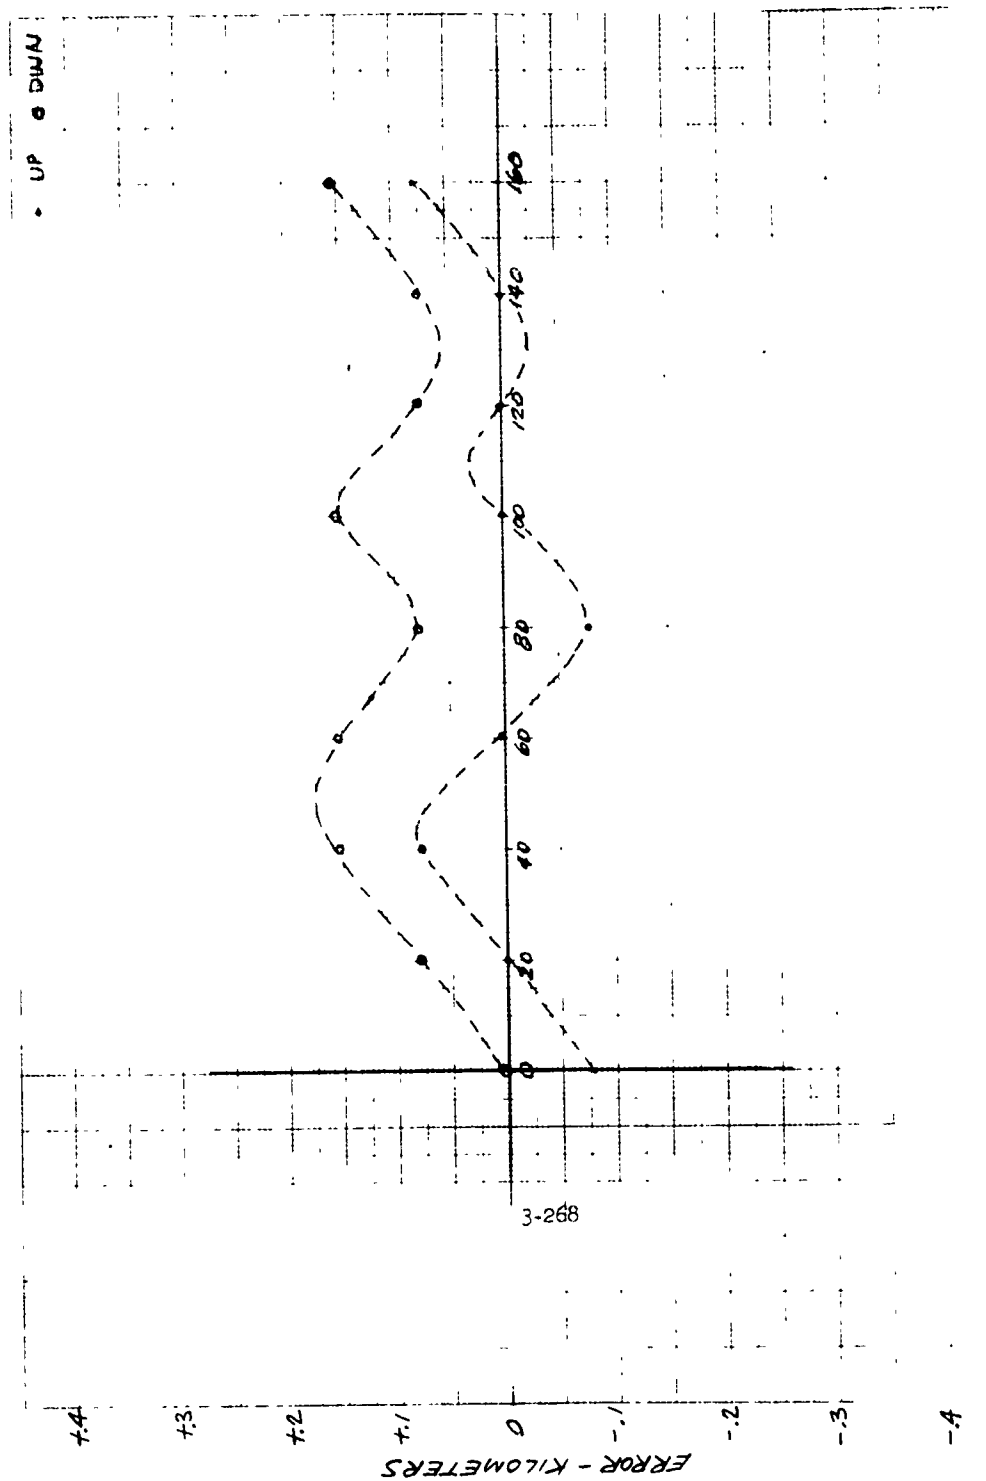
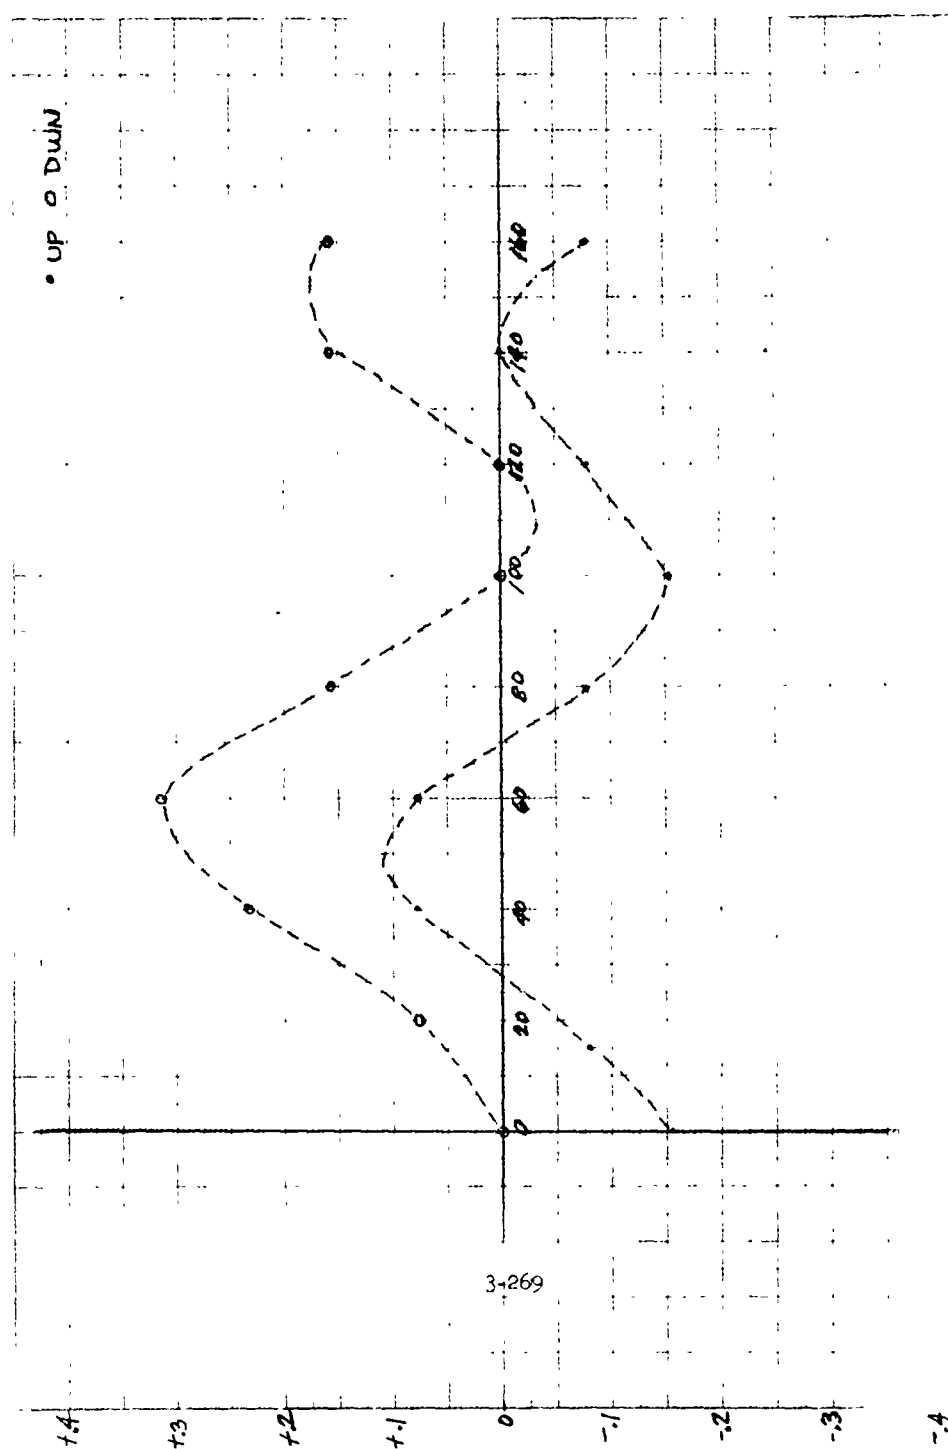
Figure 3-95. E/W Control Indicator (Navigator) PP Calibration.

Figure 3-96. N/S Control Indicator (Navigator) PP Calibration Check J0V1-B (33).

1. Wind calculation functioned correctly.
2. The TAS transmitter/navigator interface appears to have a 10-kt error. With the pitot tube tester set to 180 Kts, the G/S indicated on the VSI with zero wind is 170 Kts.
3. The present position digital readout on the control indicator has approximately 78 meters average error in both N/S and E/W displays. This error does not require any gear train adjustment (figures 3-95 and 3-96).

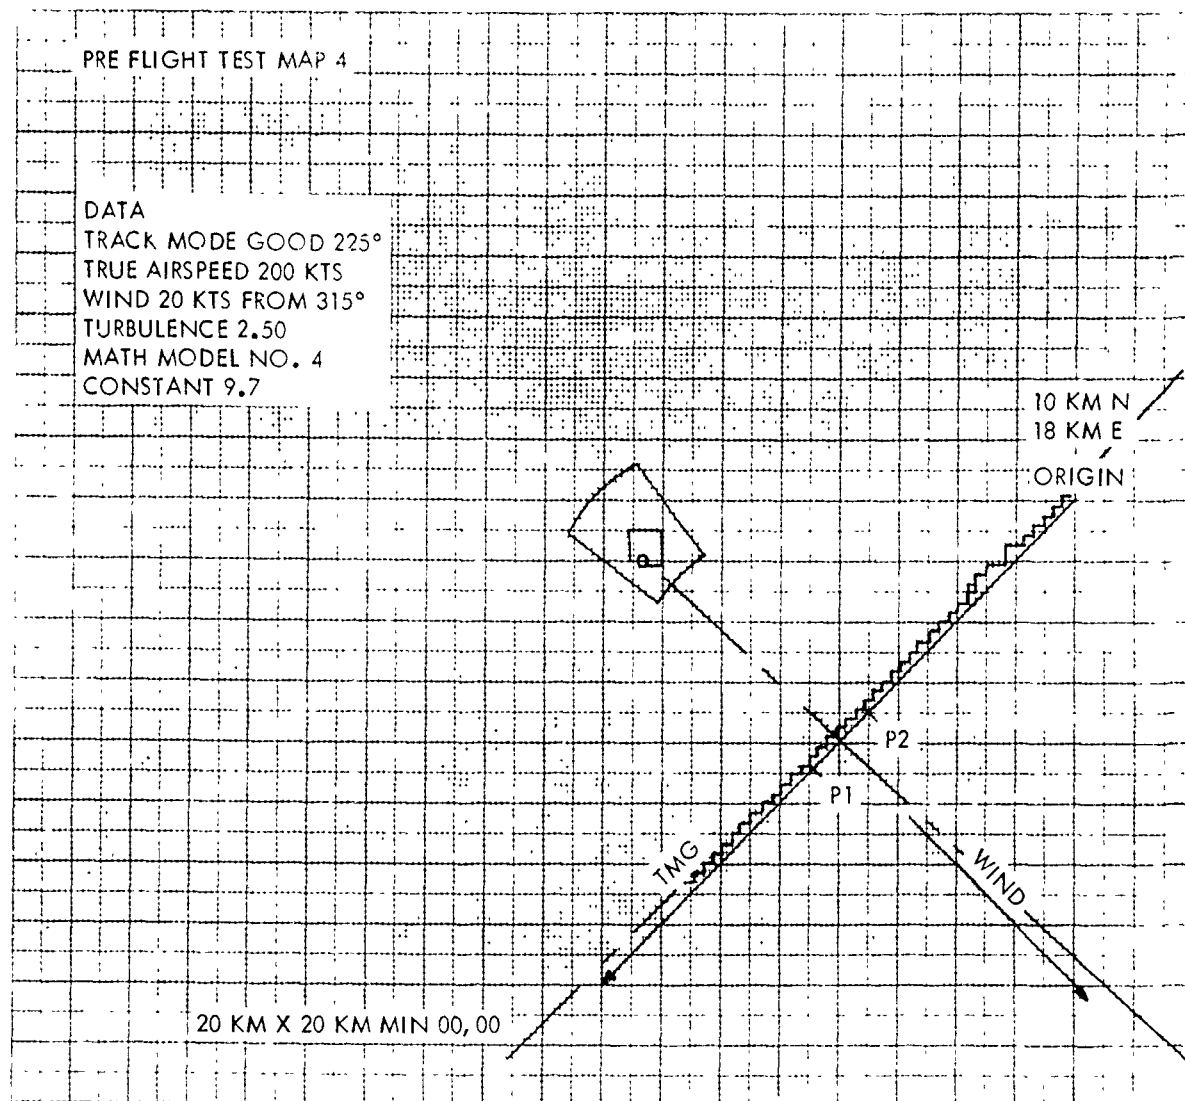
Figure 3-97. Preflight Test Map 1—J0V1-B (33).

Figure 3-98. Preflight Test Map 2-J0V1-B (33).

Figure 3-99. Preflight Test Map 3-J0V1-B (33).

Figure 3-100. Preflight Test Map 4—J0V1-B (33).

3.12.6.8 Test Problems. Four test problems were run (figures 3-97 through 3-100). The test problems define an area in which the offset plots should have occurred. In all cases, the plots occurred within the specified area.

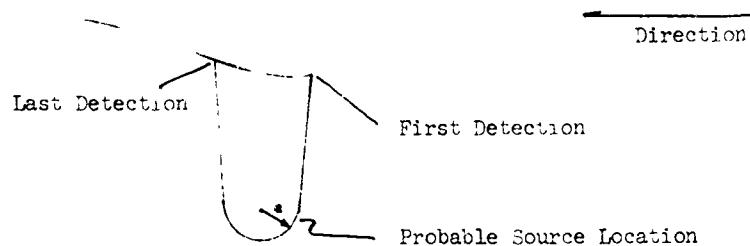
The most desirable non-interrupted plot is a method that outlines the signal path and encircles the probable source location in the manner illustrated below. The radius(e) of this plot is equivalent to the total plotter/sensor/scalar accuracy and shows the location from which the signal is estimated to emanate.

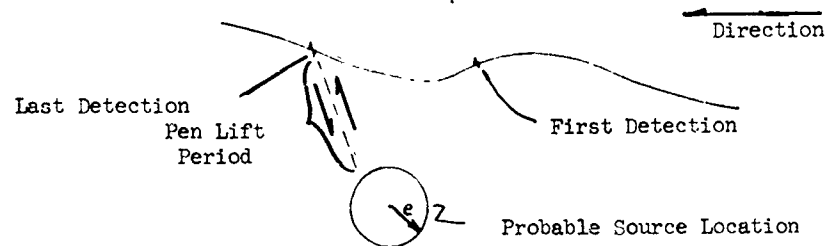
The most desirable interrupted signal indicates the probable source location and the points on the course plot where the signal was first and last detected. As in the previous case, the radius(e) of the plot is a function of the total plotter/sensor/scalar accuracy. Any interrupted plot requires a pen lift capability of the plotter, that is - the pen will lift off the course plot, trace the estimated source location, lift, and pick up the course plot where it left off.

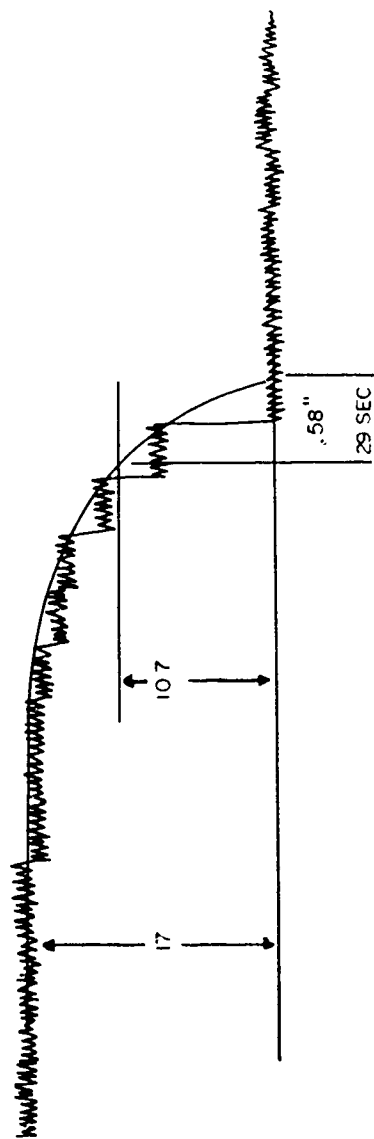
Figure 5-13. Detector with Blocks Step Response to C/N

50 K SCALE
≈ 25 K

The response of the 224 Phase 2 detector with blocks in the humidifier to a step input is shown on Figure 5-13. The effect of blocking off unused humidifier volume is illustrated by Figure 5-14 in which the same detector response is measured but without the blocks. As can be seen the time to reach 63 percent of maximum is reduced from about 0.4 seconds to 0.3 seconds by the blocks.

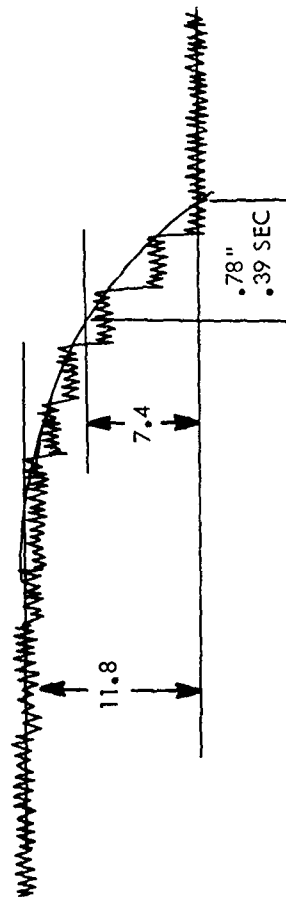
Figure 5-14. Detector Without Blocks Step Response to CN.

50K SCALE
≈ 25K

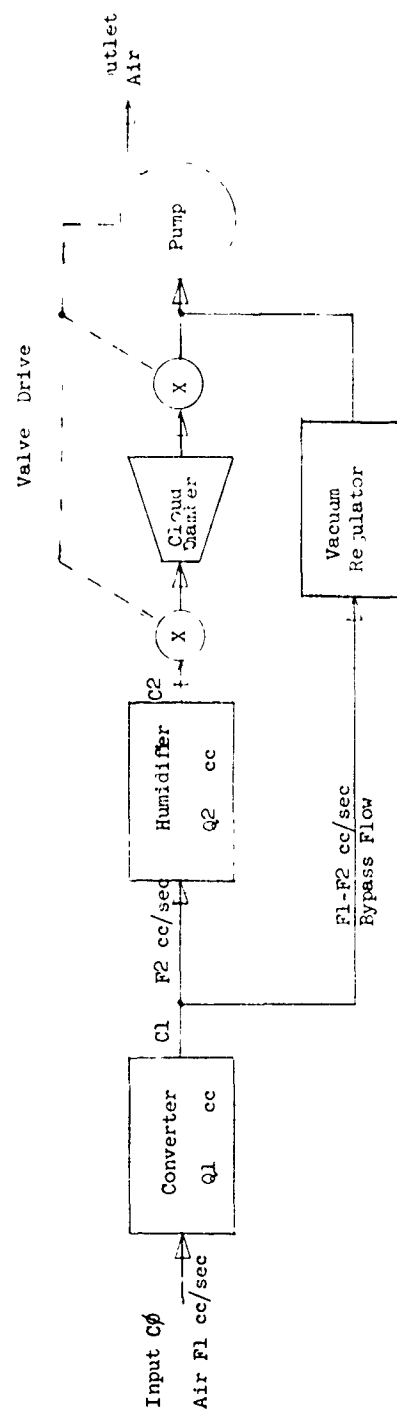
CONVERTER AND DETECTOR ELO X DIAGRAM

F = Flow Rate cc/sec
 Q = Chamber Volume cc
 C = Nuclei concentration per cc

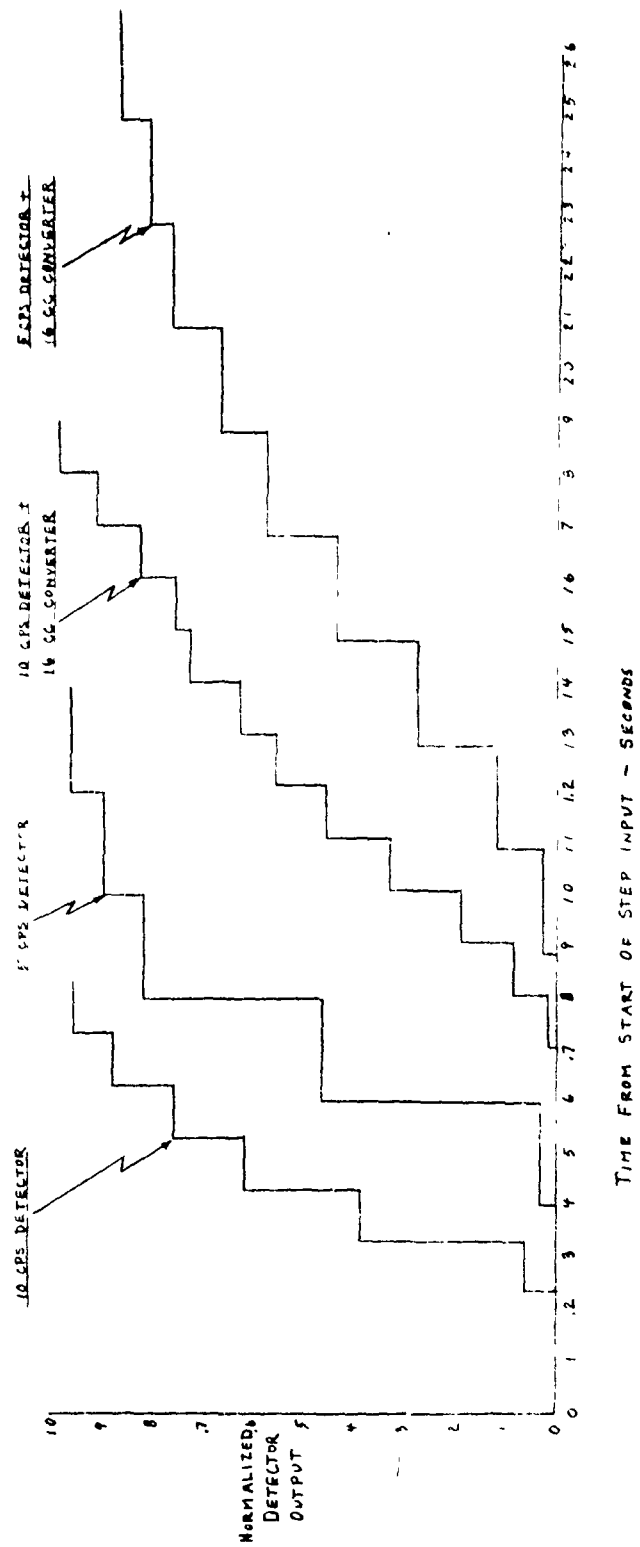
Figure 5-27 Typical Detector Response

TRANSIENT RESPONSE CHARACTERISTICS OF 224 BY DETECTORS—
FOR A STEP INPUT

The transient rise time of the converter and 10 cps detector is appreciably faster than that of the converter and 5 cps detector. The ratio of the rise times is approximately the same as the ratio of the flow rates which follows theory.

Typical detector responses for step input signals are shown on Figure 5-27. These responses represent averages of several runs. This was done to filter detector noise effects.

The transient response of the latest detector is more rapid than the response of the previous design. This is due to the decreased volume of the humidifier with the new wick assembly. Humidifier volume has changed from 6.75 to 3.75 cc. The effect of the drilled passages in the block is still apparent when the 224 detector response is compared with the 223 detector response.
